Airport Inspections / Corrective Action Plans / LiDAR

Georgia Airports Association
November 1, 2023

Presented by: Alan Hood, GDOT
Airport Safety Data Program Manager

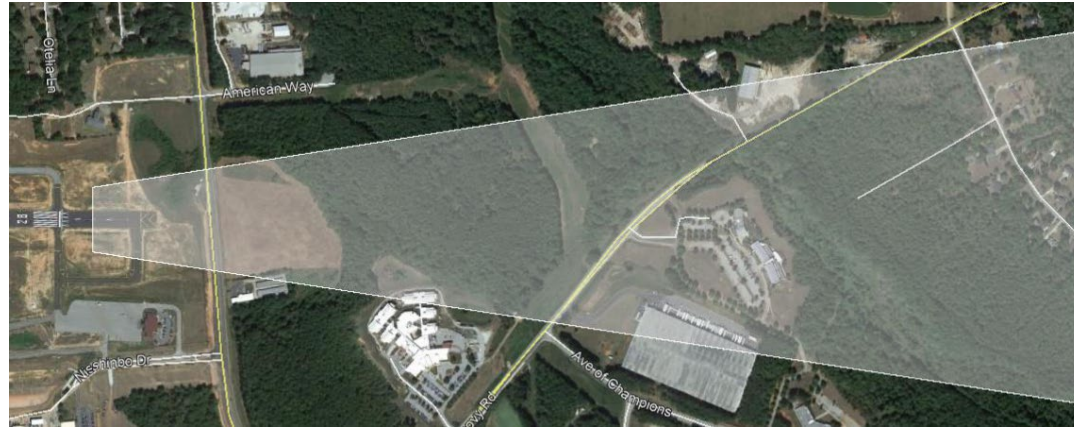
FAA Threshold Siting (20:1, 30:1)

- TSS Surface 4 or 5 Surface starts 200' from threshold (20:1) – Most Common
 - Maintain night minimums by keeping this surface clear

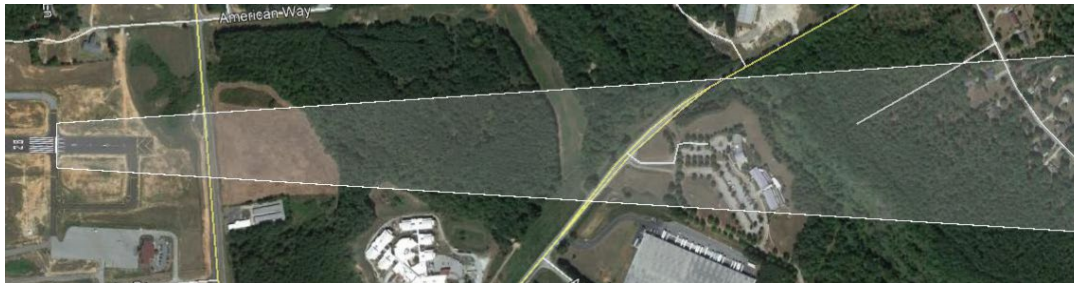
- TSS Type 6 Surface starts at threshold (30:1) – vertical guided approach
